EXFOLIATION OF MAGNESIUM-GRAPHITE COMPOSITES: A COMBINED METALLOGRAPHIC AND ANALYTICAL APPROACH.

Marc H. Richman, et al

Army Materials and Mechanics Research Center Watertown, Massachusetts

July 1973

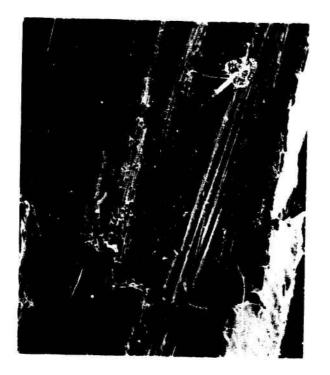
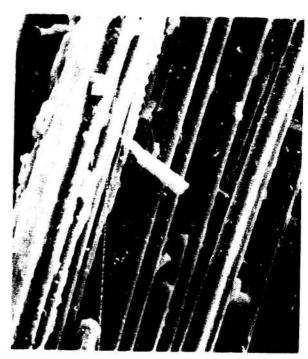
Figure 4. AZ91C Mg-Graphite fiber composite exfoliated surface, area A

The surfaces at two sites are shown at two different magnifications in Figures 4a and b and 5a and b. From these scanning electron micrographs it is evident that there is little if any infiltration of the matrix alloy into the fiber bundles. This results in considerable porosity and lack of wetting of the graphite fibers by the magnesium alloy matrix. Indeed, in Figure 5a a very large void is clearly evident. This sparsity of magnesium alloy matrix adjacent to the fibers and the large voids suggest, as did the optical micrographs, that exfoliation either produces voids and debonding or is caused by them.

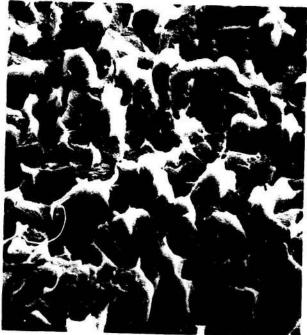
Figure 6. AZ91C Mg-Grahite fiber composite, good area (fractured)

It is easy to see that there is very little evidence of internal porosity or voids in the good region of the composite and that the wetting and bonding is extremely good. In Figure 6b the fibers break off cleanly at the fracture surface while considerable plastic deformation of the matrix has occurred. There is also clear evidence that the intimate bonding of the matrix to these fibers remains even after fracture. It should be noted that despite the convoluted shape of the Celion fibers, excellent infiltration has been obtained.

While the above discussion indicates that magnesium-graphite should not be worthwhile as a composite system, all danger of exfoliation can be removed if good wetting and bonding are achieved. This holds for both magnesium and magnesium alloy matrices. This can be clearly seen by studying the scanning electron micrographs of the good areas in Figure 6 or the optical micrograph of Figure 3a. If such wetting and bonding can be achieved, there is no danger of exfoliation. This has, indeed, been observed in practice in both the pure magnesium and the AZ91C alloy matrices. There is also ample evidence that the elimination of the aluminum from any alloy renders the material more suitable as a matrix metal for this composite system.

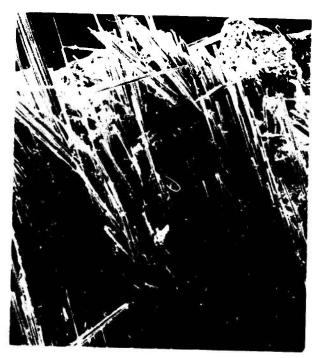
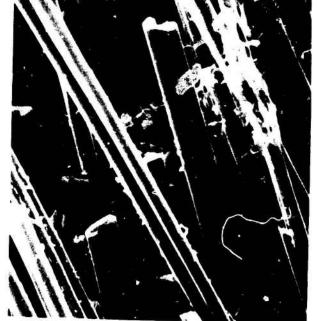
Figure 7. AZ91C Mg-Graphite fiber composite, bad area (fractured)

In contrast to the good area of Figures 6a and b, the bad regions of Figures 7a and b show little or no wetting and bonding. The fibers are virtually devoid of matrix metal and are fractured at various points along their lengths. Scattered small particles of matrix metal may be seen in Figure 7b adhering to some fibers.

These scanning electron micrographs clearly indicate a lack of any wetting or bonding between fiber and matrix in the exfoliated regions of the composite while in the good regions there is excellent wetting and bonding.
